## DIRECTION DEPARTEMENTALE DE L'EQUIPEMENT, VENDEE SEA BUOYS – FRANCE

Subject : Test application Zinga on marine buoy in Noirmoutier.

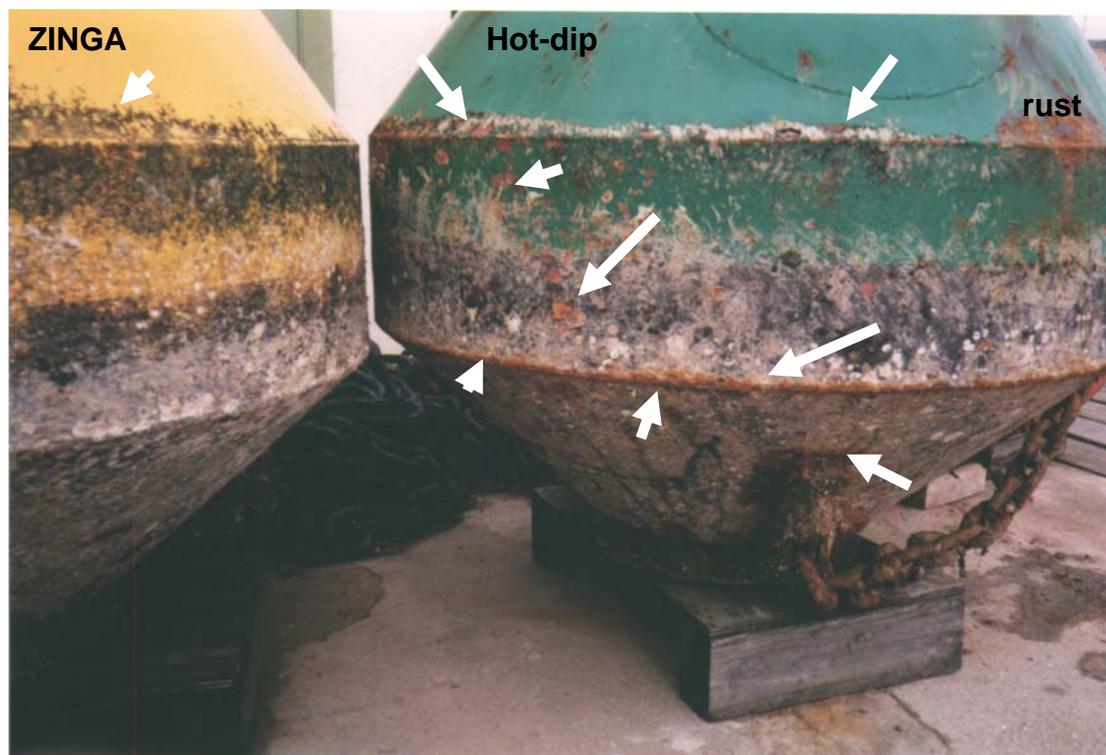
These two sea buoys have been floating in the Atlantic Ocean for 4 years. The yellow buoy, a mild steel buoy treated with Zinga, was compared to the green buoy that was galvanised by the traditional hot-dip process. The two buoys had received the same type of topcoats with the same layer thickness, with a supplementary adhesion coating for the hot-dipped buoy.

Conclusion of this test : the buoy treated with Zinga showed no trace of rust, but the hot-dip galvanised buoy was severely corroded in several places.
