## DIRECTION DEPARTEMENTALE DE L'EQUIPEMENT, VENDEE SEA BUOYS – FRANCE

Subject : Test application Zinga on marine buoy in Noirmoutier.

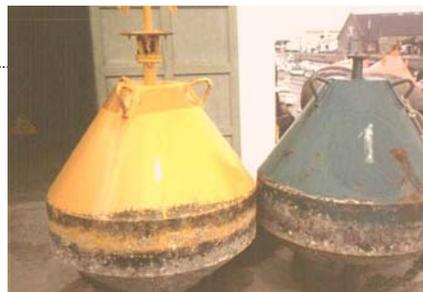
- After a period of nearly 4 years in the sea, the buoy doesn't show a single rust spot. The yellow paint needs a little refreshing and shows some blisters due to shocks. The Zinga product is visible on these spots, without any trace of rust. The buoy is in good general shape and can be launched into the water again for an equivalent period of time. In these conditions the ZINGA product gives us satisfaction because of its efficient anti rust character in a marine environment.
